# **Quality check list, Andasy School.**

Date: 28th of May till 10th of June Inspected By: MAHASOA Auguste

Pouring of columns in reinforced concrete for the two identical schools and Ground beams of school has office

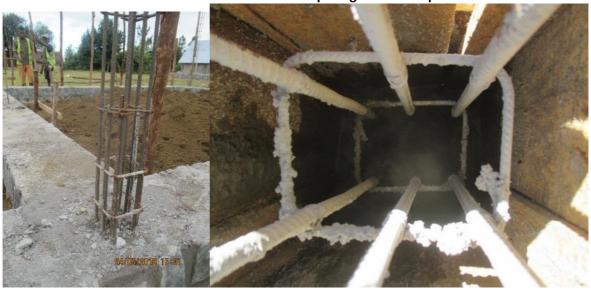
Reinforcement of column before pouring

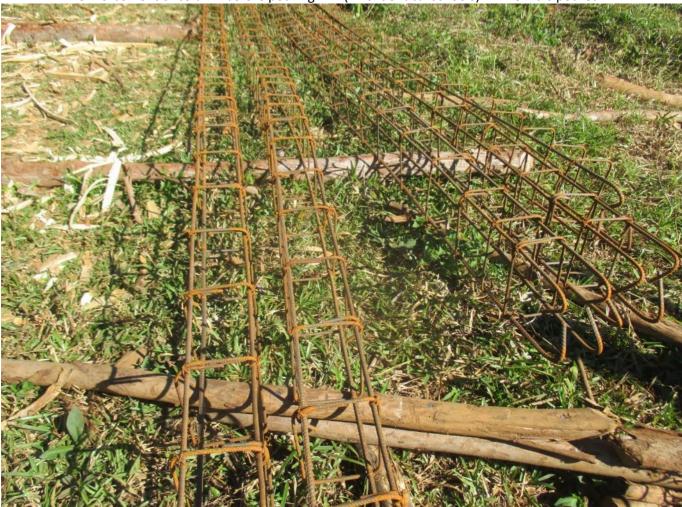
Prepared reinforcement of horizontals ring beams are already prepared in site. But the additional reinforcement are the missing things in them.

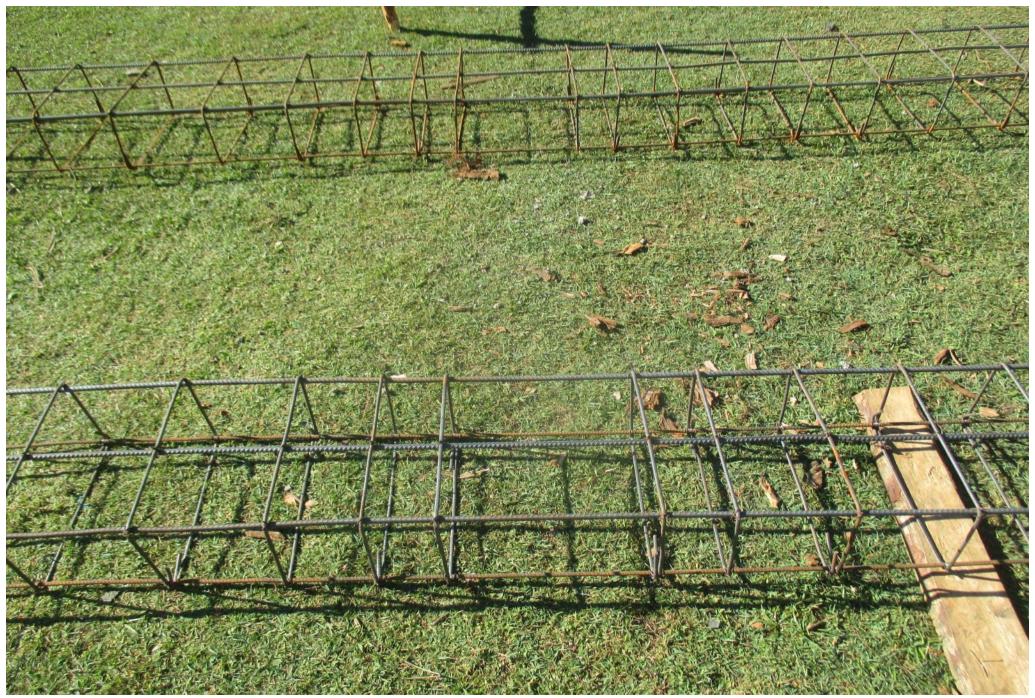
Reinforcement of ground beams in preparation (upset down situation)

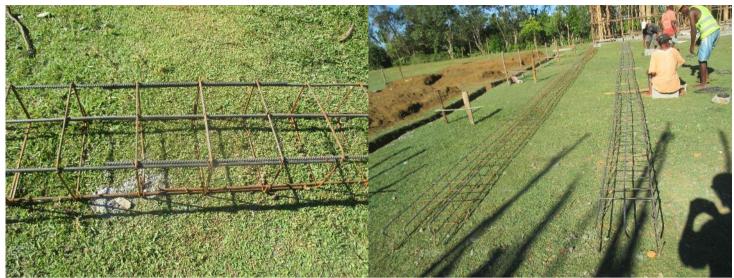
(Bottom view of ground beam's) Their Overlapping Longitudinal reinforcements in assembly or in preparation

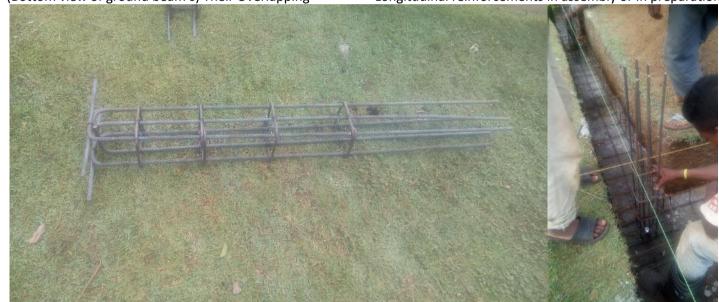
External Reinforcement of columns, 200\*220mm of section

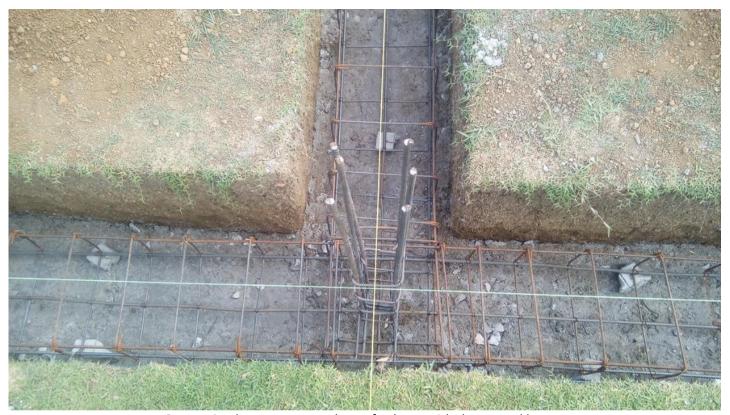
Connection between starter bars of column with the ground beams

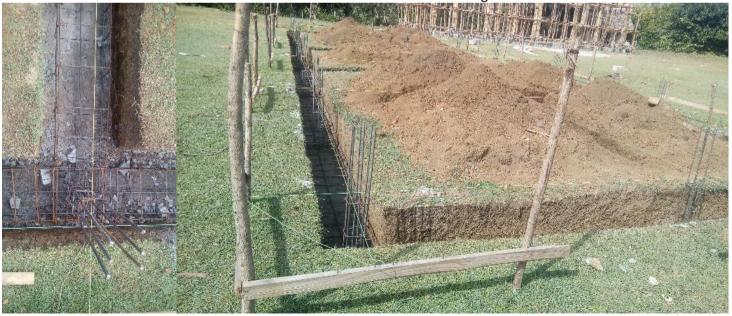
Middle column's

fixed reinforcement of ground beams and starter bars of every columns

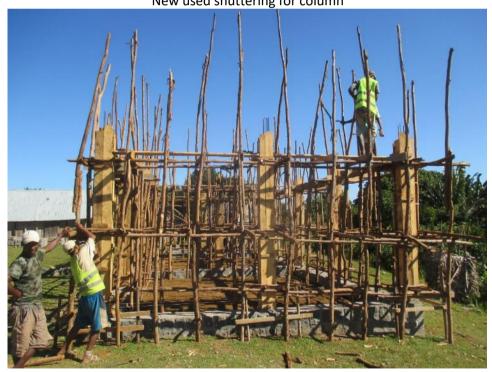
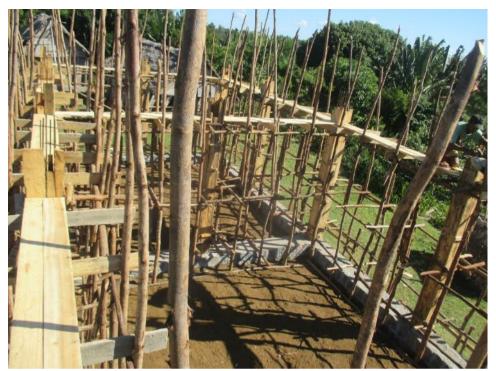
Bottom of the ring beams has already fixed in place for security reason

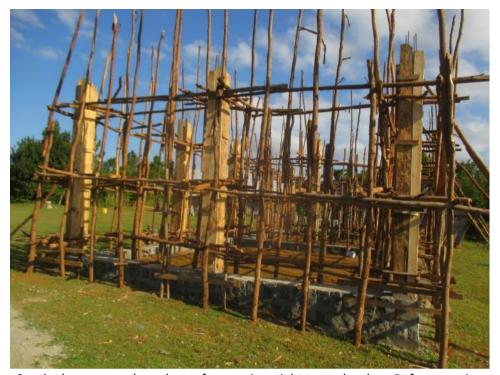
Surely they are ready and sure for pouring, tight to each other. Before pouring

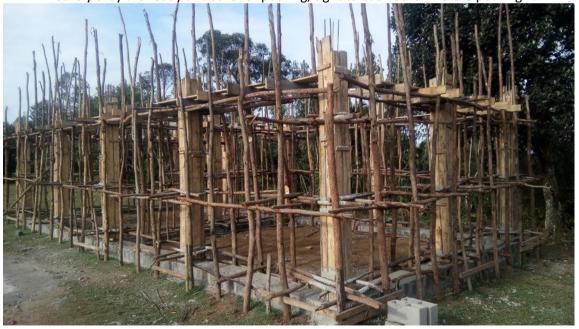
Scaffolding and shuttering of column after pouring

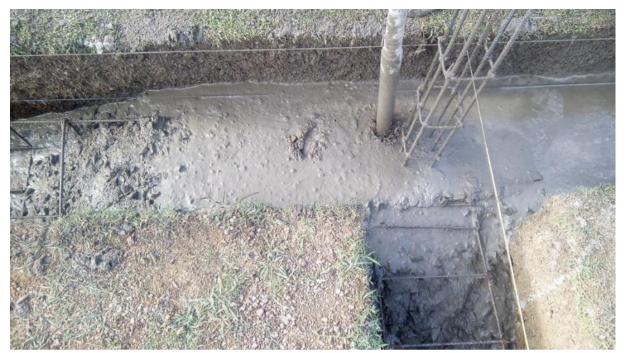
Pouring the junction of the foundation, middle of the reinforcement is respected

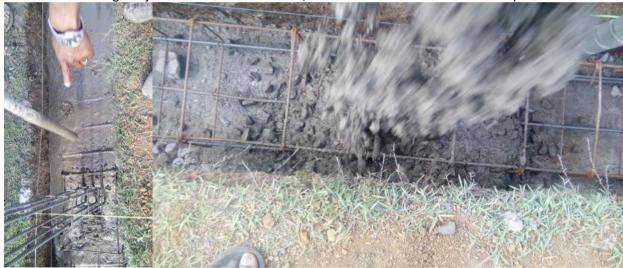
Showing where to be add

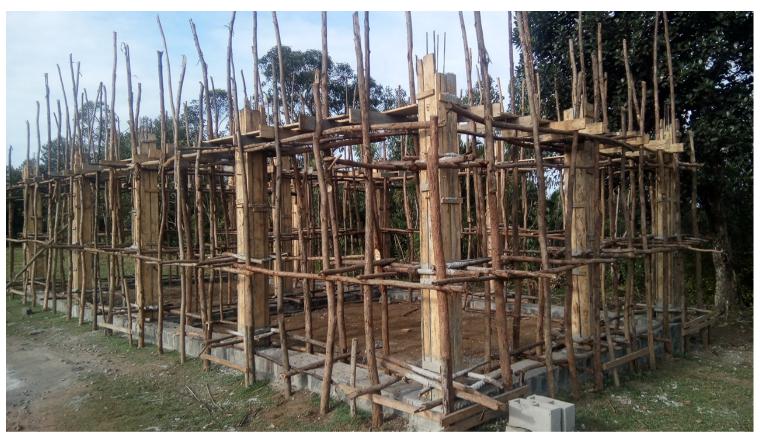
Shuttering of columns hasn't yet removed. We're in horizontal ring beams level.

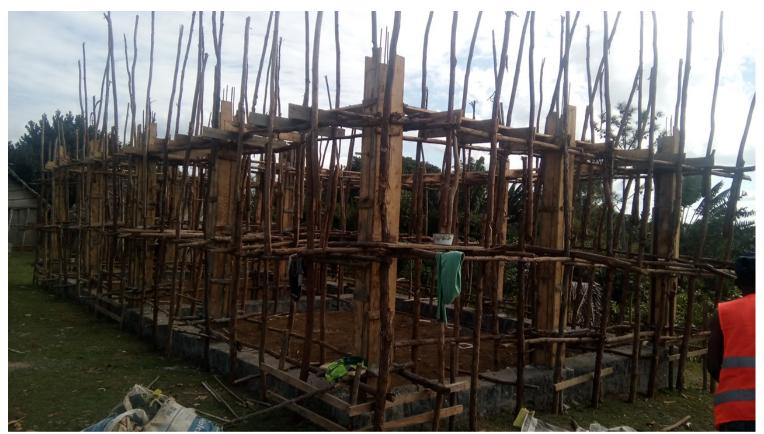
West one (Two identical school)

The same level as its twin
